Five-Year Review Report

Kassouf-Kimerling Superfund Site Tampa, Hillsborough County, Florida

Prepared for U.S. Environmental Protection Agency, Region IV June 2004

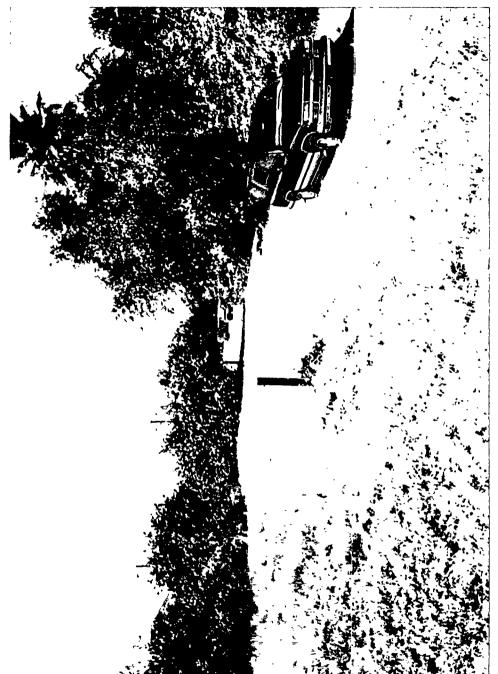
Photo #1. Kassouf-Kimerling Superfund Site - South Gate
